MCC Power Correction Capacitor Disconnect

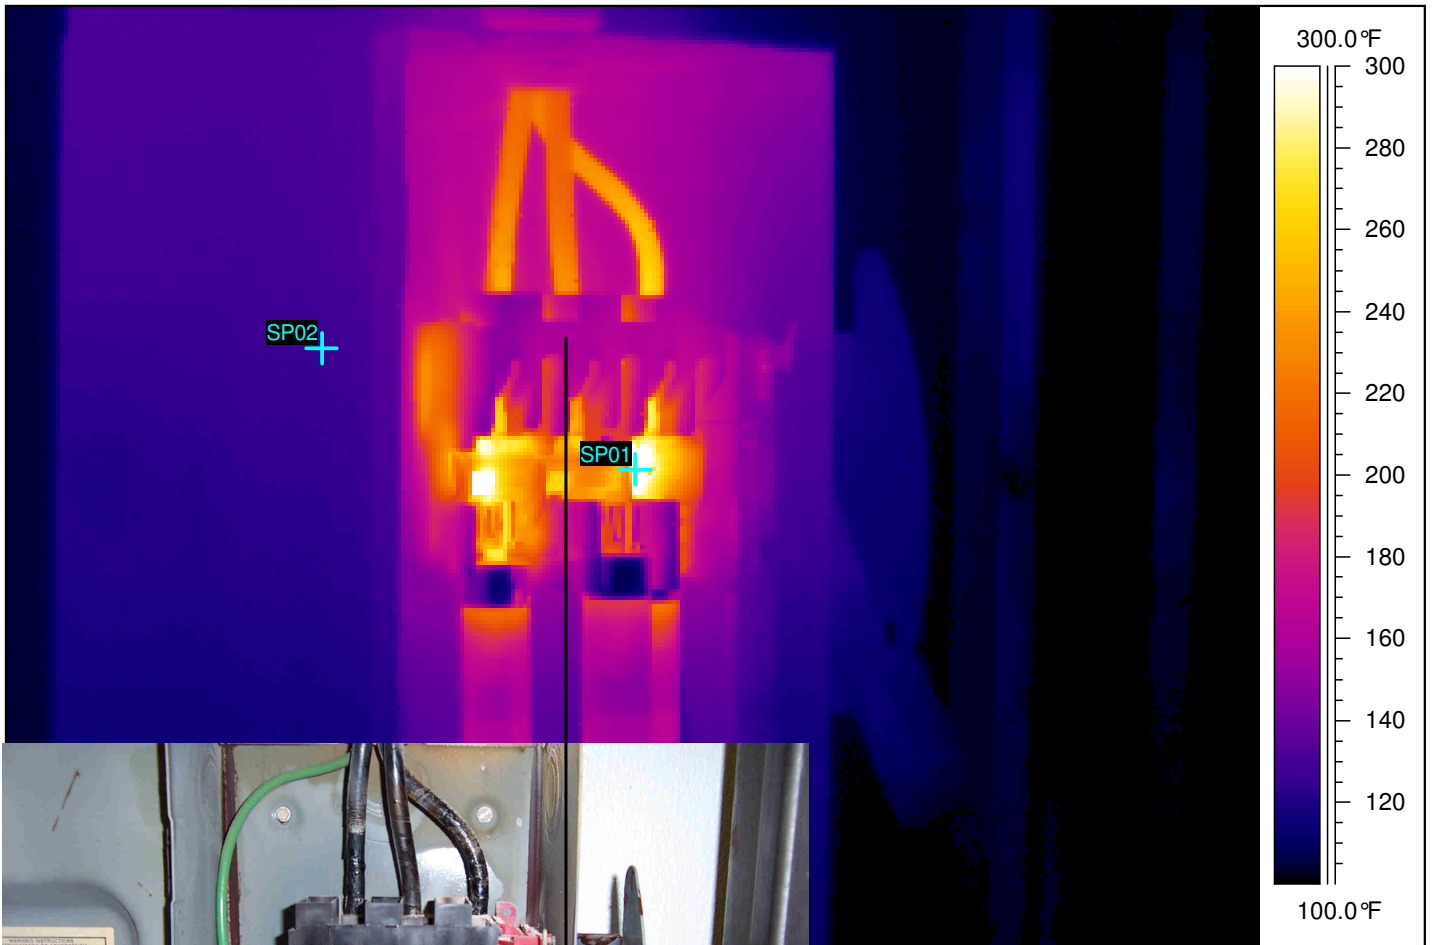
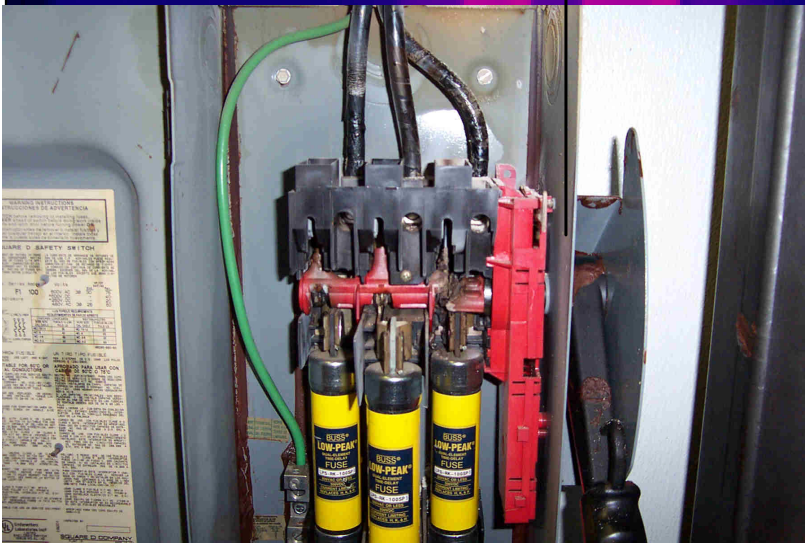
IR Text Comment		Value			
Location		MCC Power Correction Capacitor Disconnect			
Equipment		Capacitor Bank Disconnect			
Spot 1	357.4 °F	Spot 2	127.3 °F	RISE	230.1 °F

NOTE: The disconnect is STILL ENERGIZED although the switch handle shows it is open. The switch contact assembly is welded closed. Lockout / Tagout MCC. TEST BEFORE TOUCH!
Replace disconnect and wiring.
